RIGHT BANK DRINKING WATER TREATMENT  
PLANT REHABILITATION

SUSTAINMENT ASSESSMENT

**SIGIR PA-07-106**

**OCTOBER 22, 2007**

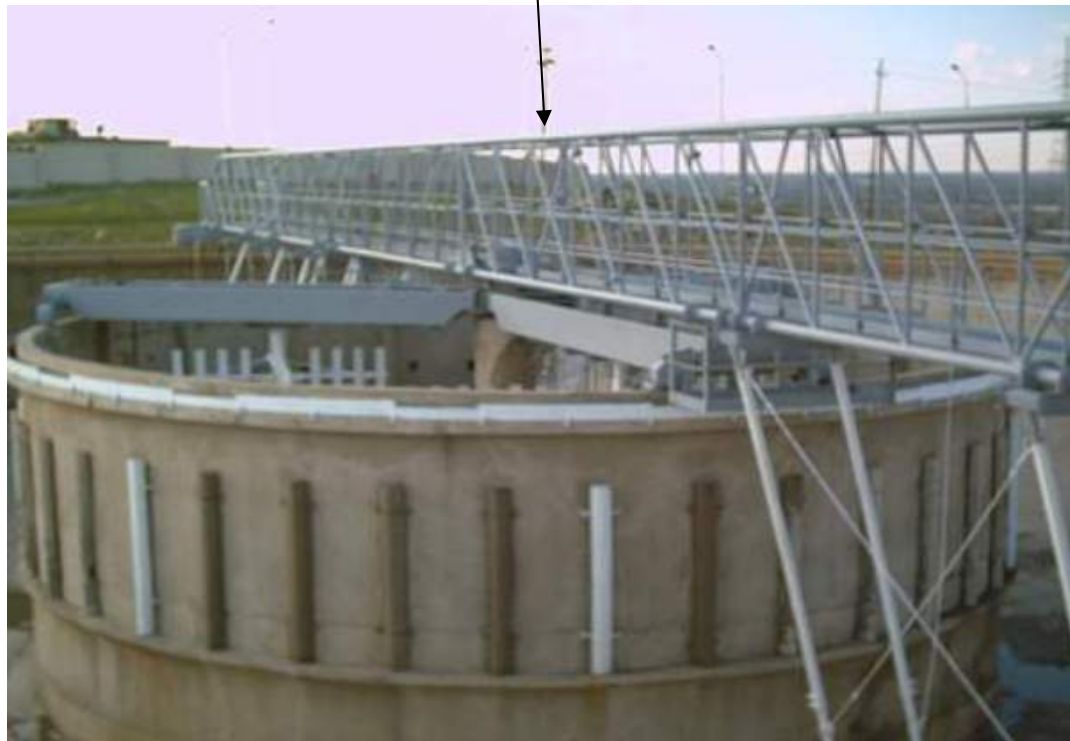
**Site Photo 1. Right Bank DWTP (Photo courtesy of USACE)**

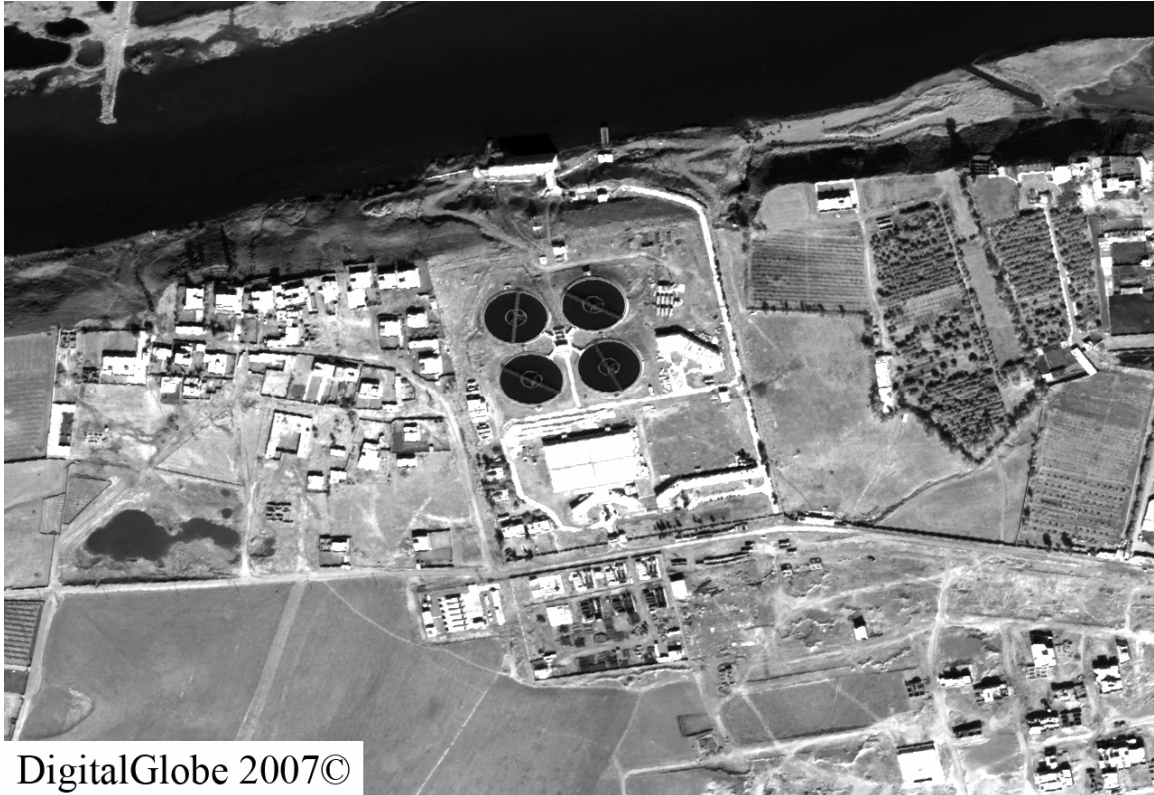
**Aerial Image 1. Imagery overview of the Right Bank Drinking Water Treatment Plant taken on 27 FEB07.**

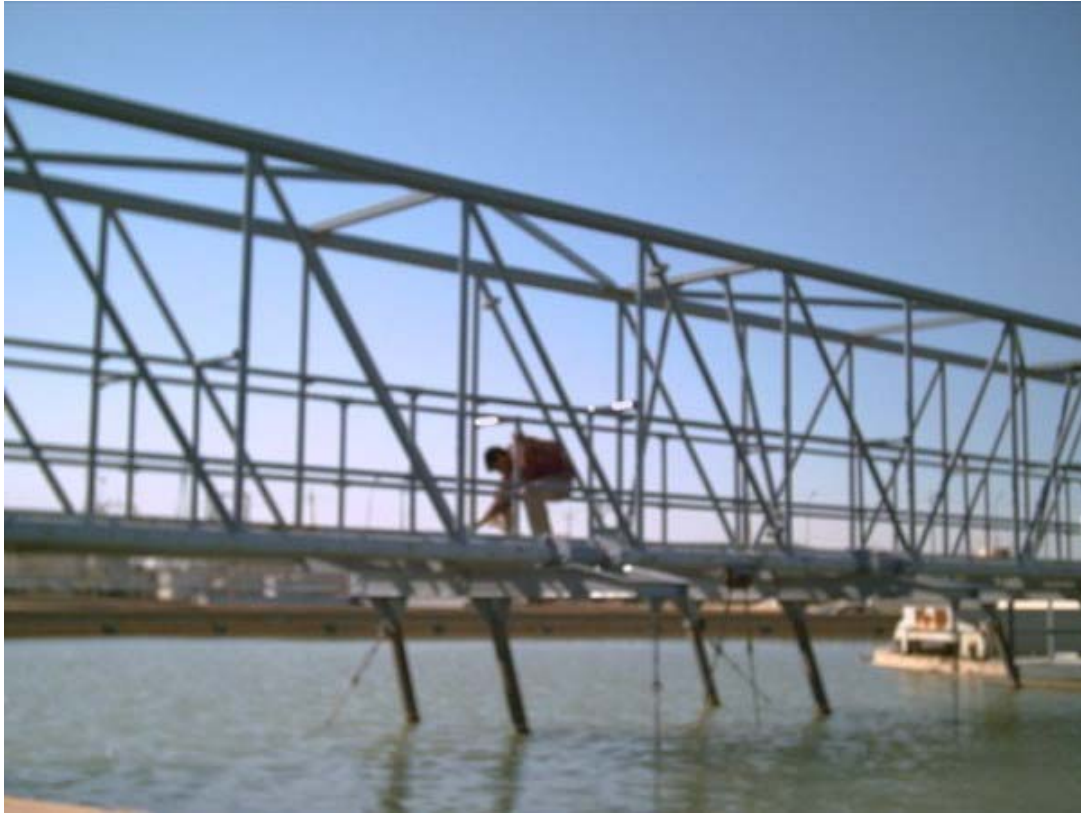
**Site Photo 2. Settling tank's sludge scrapers receiving an anti-chemical paint coating of the steel parts (Photo courtesy of USACE)**

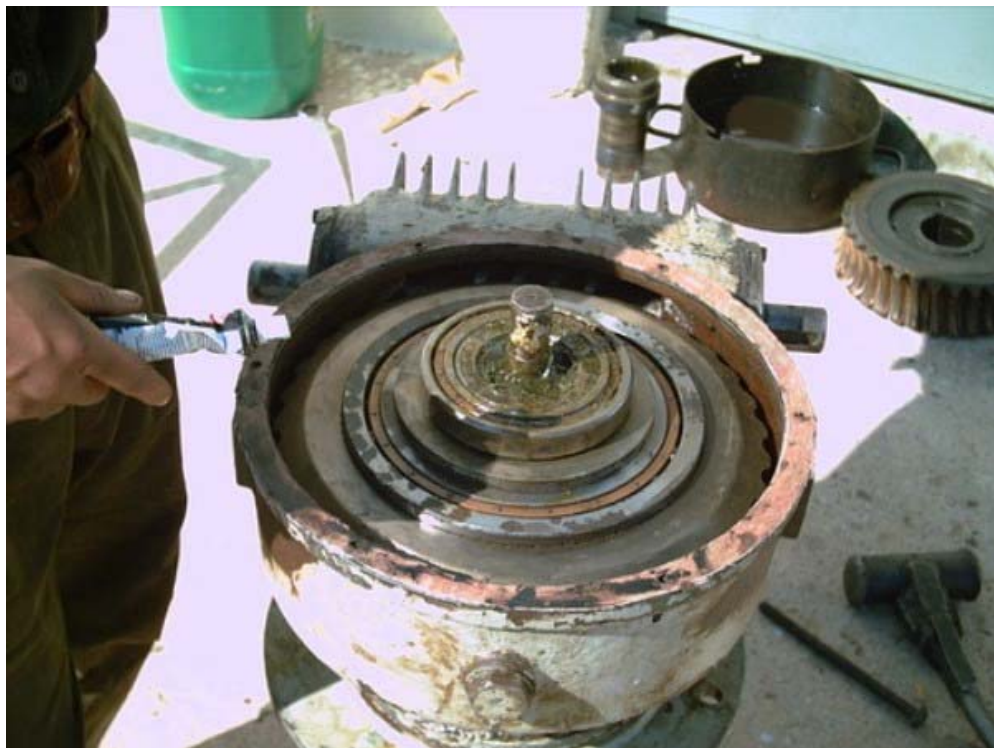
**Site Photo 3. Maintenance work on flush mixers (Photo courtesy of USACE)**

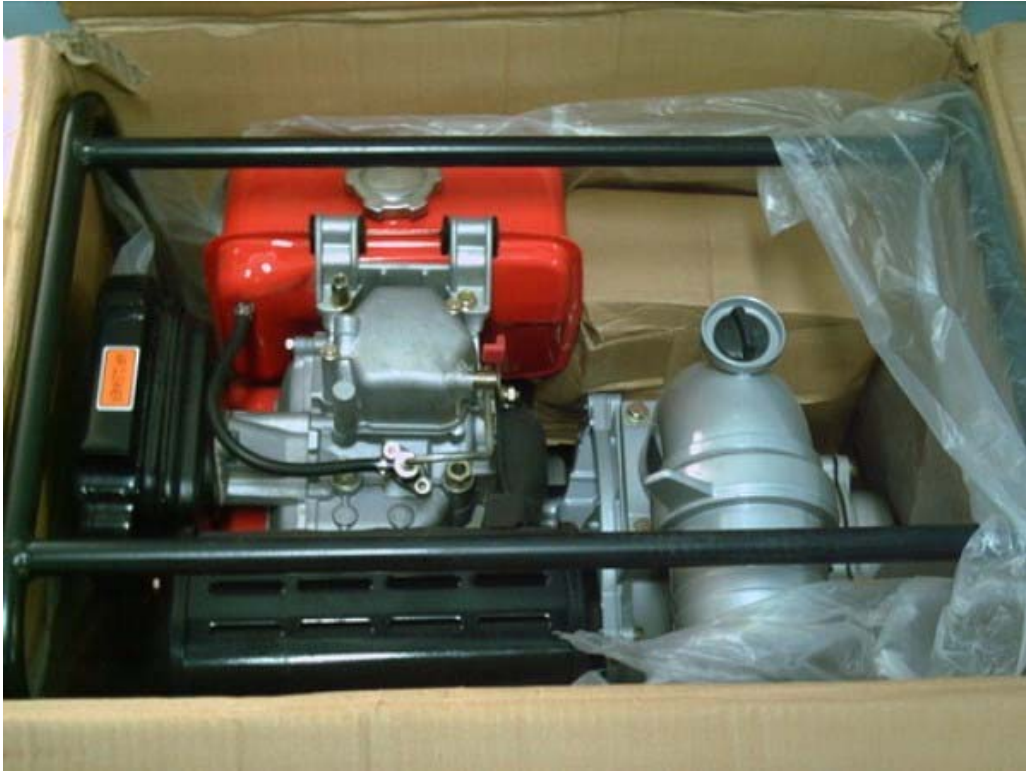
**Site Photo 4. New, uninstalled gasoline pump (Photo courtesy of USACE)**

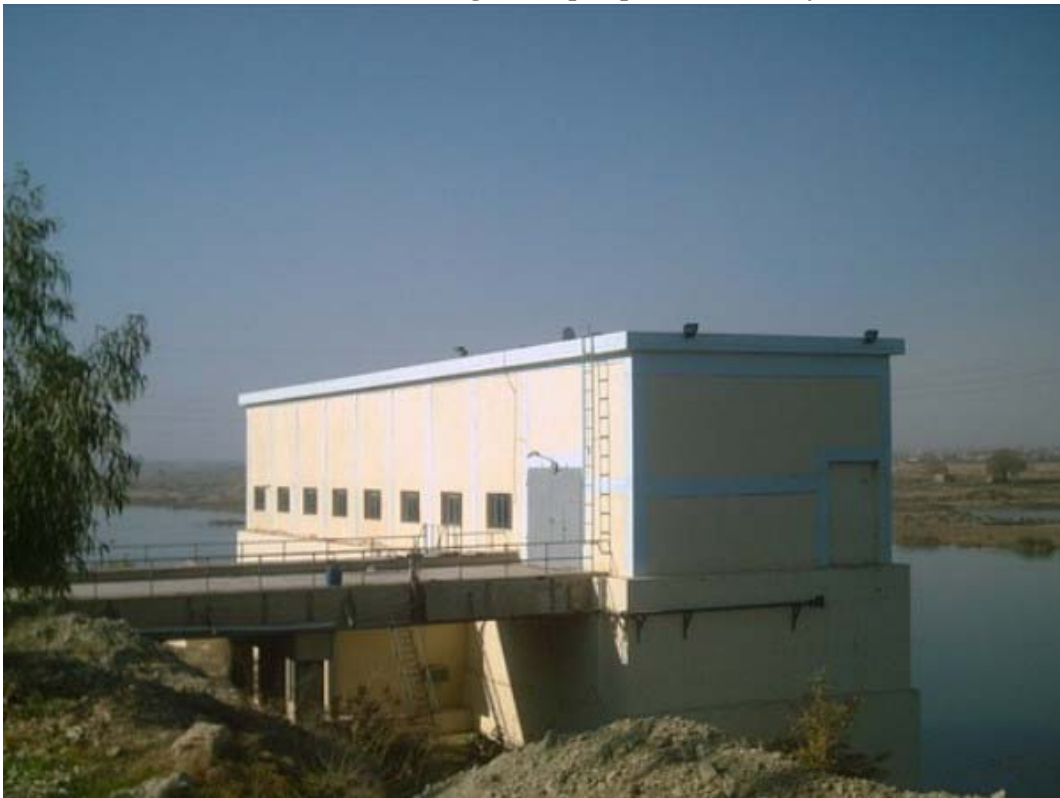
**Site Photo 5. Low- lift pumping station's newly renovated exterior (Photo courtesy of USACE)**

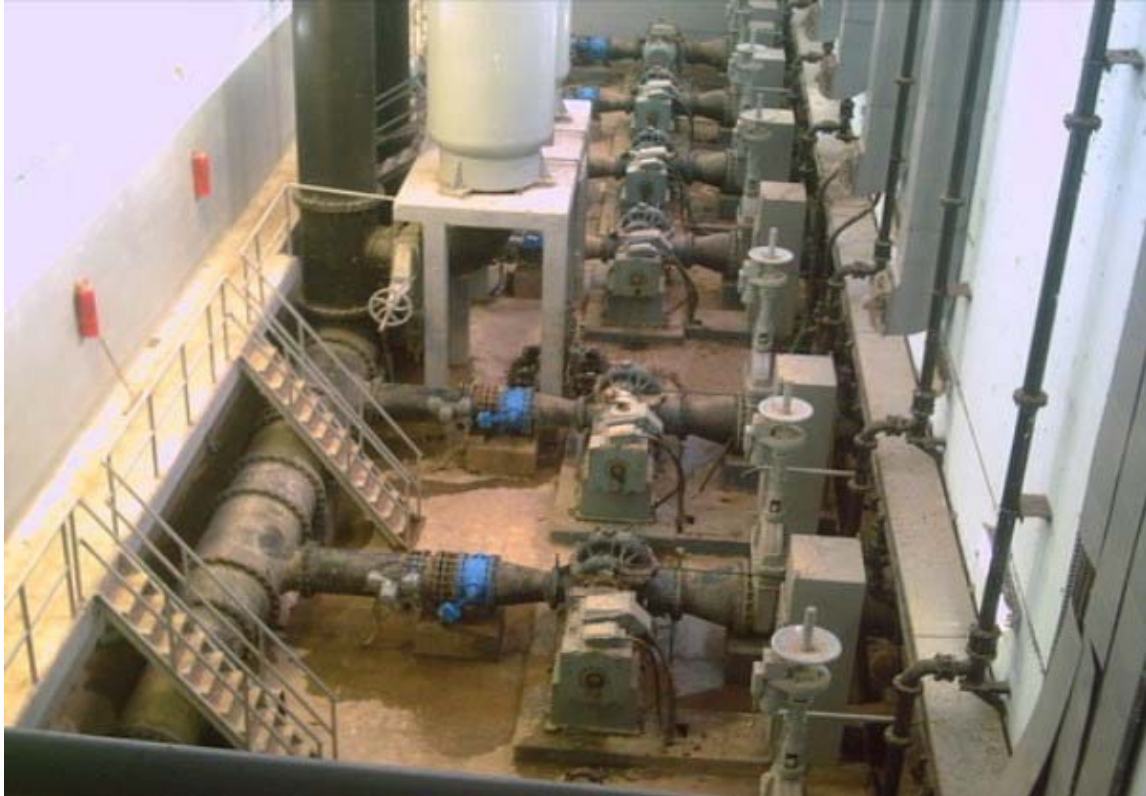
**Site Photo 6. Low- lift pumping station's newly renovated interior (Photo courtesy of USACE)**

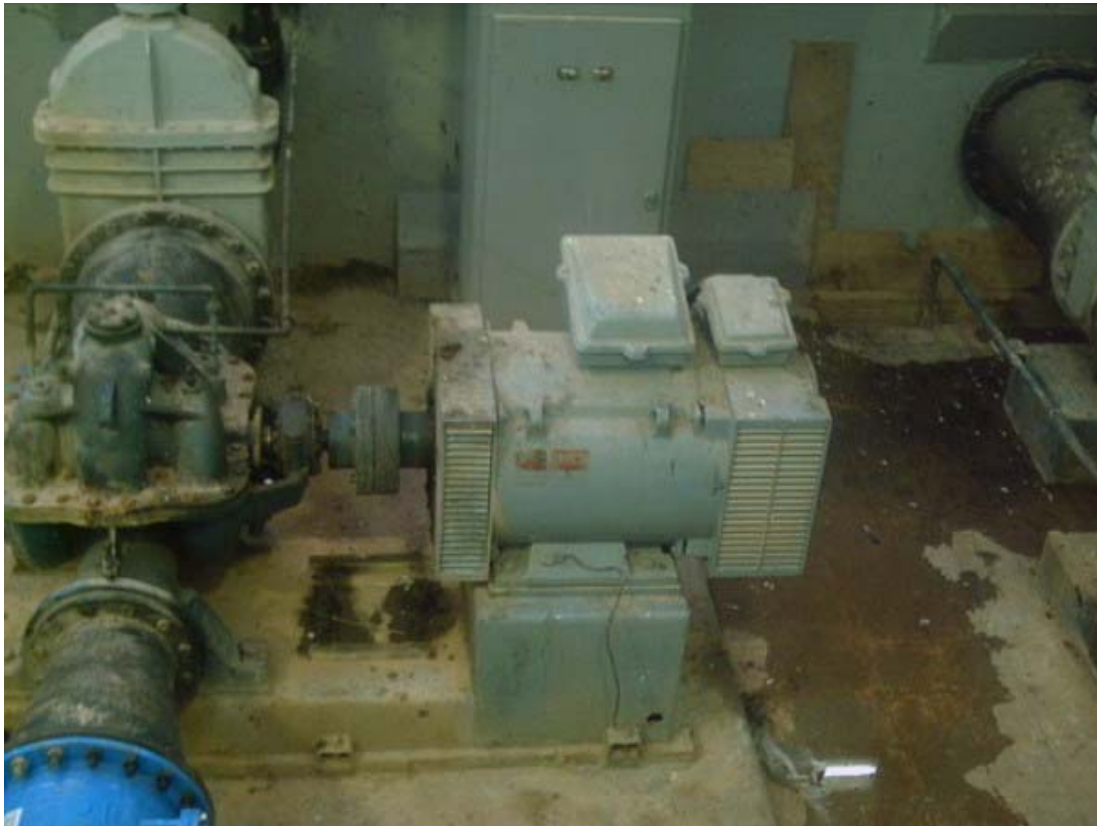
**Site Photo 7. Low-lift pumping station's 180-kilowatt motor (Photo courtesy of USACE)**

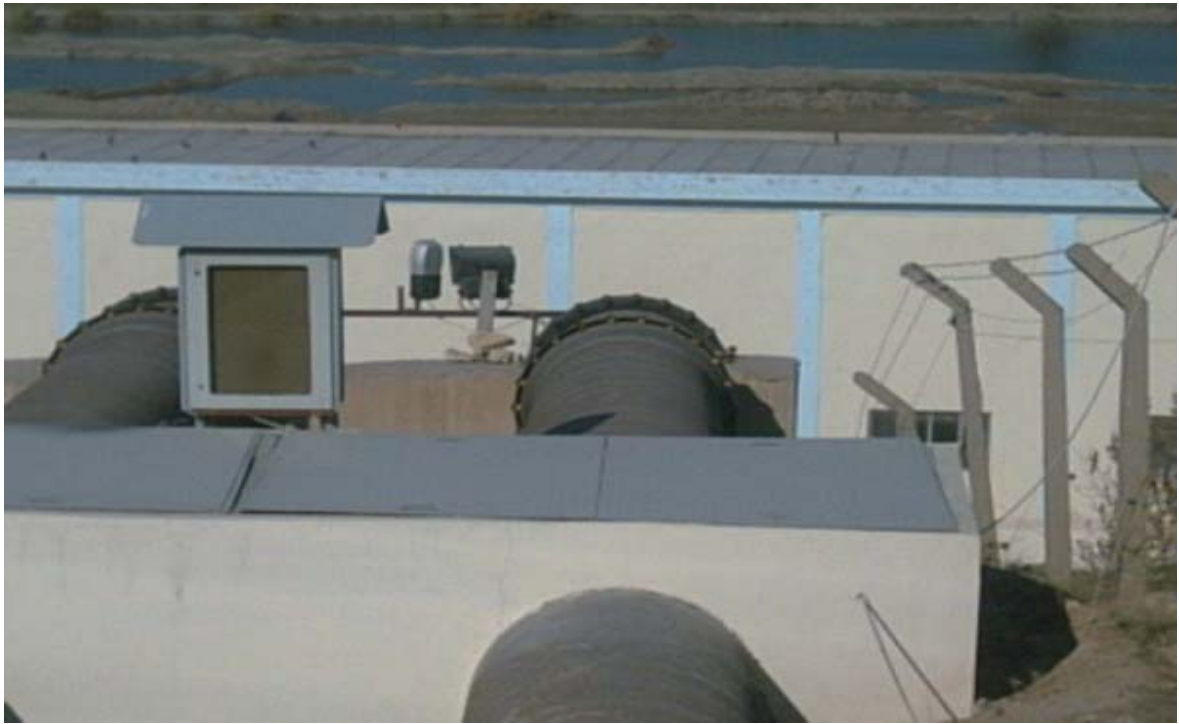
**Site Photo 8. Low-lift pumping station's flow meter (Photo courtesy of USACE)**

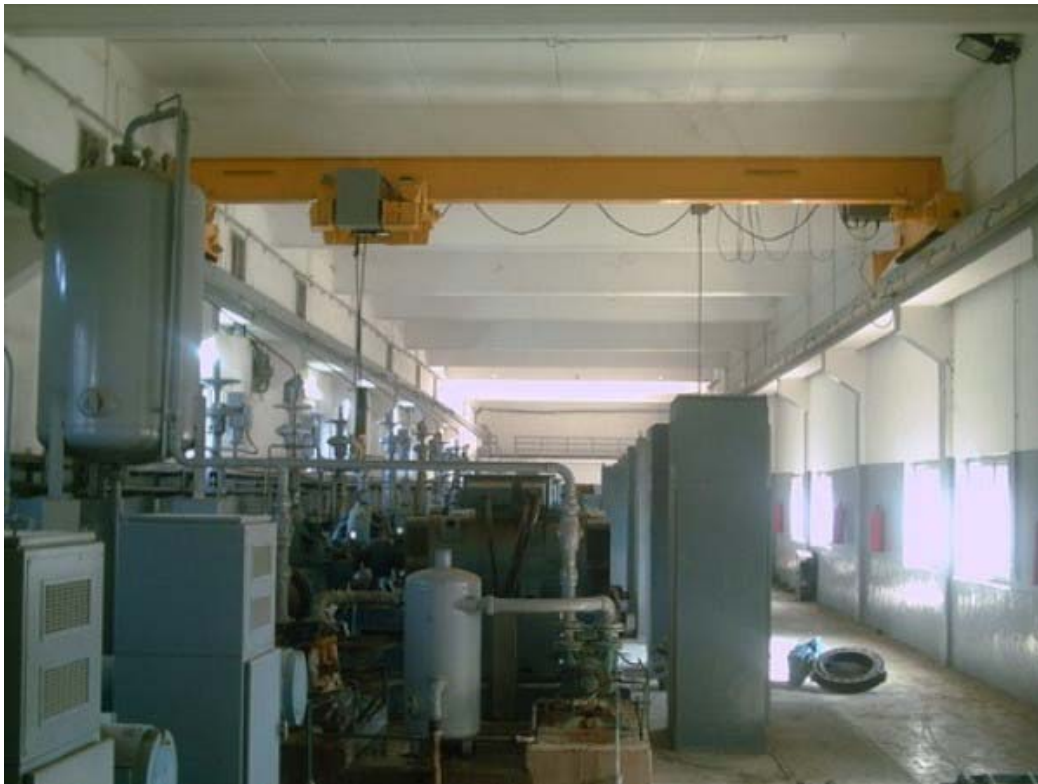
**Site Photo 9. High-lift pumping station's building interior (Photo courtesy of USACE)**

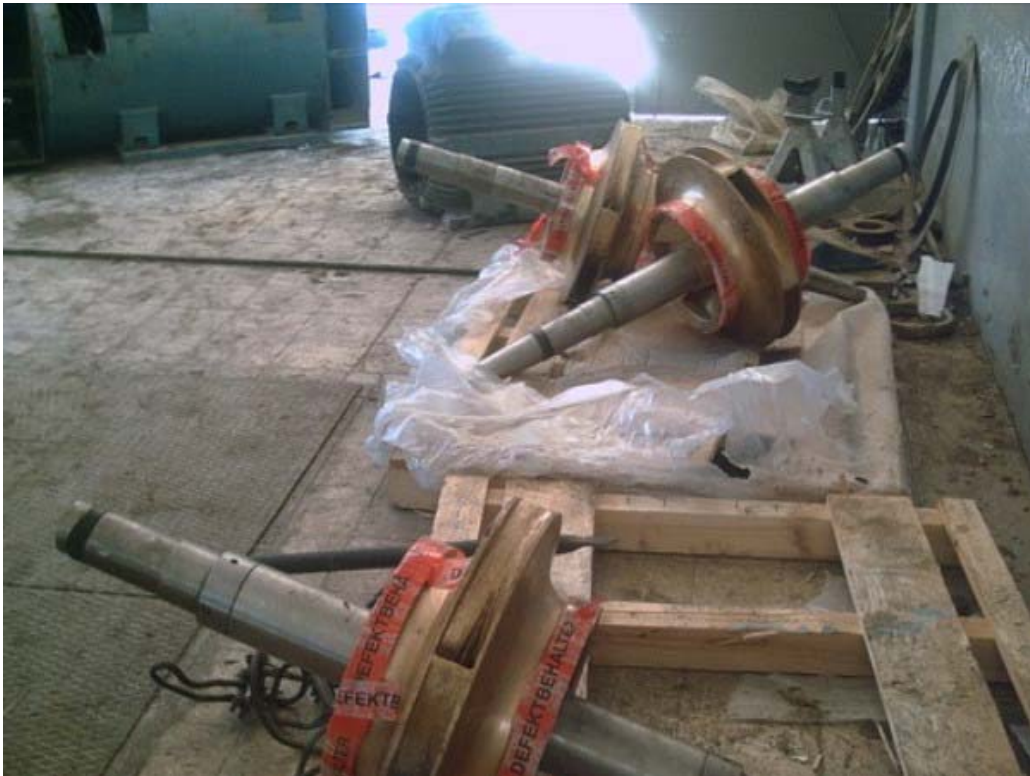
**Site Photo 10. High-lift pumping station's propeller & stainless steel shaft for pumps  
(Photo courtesy of USACE)**

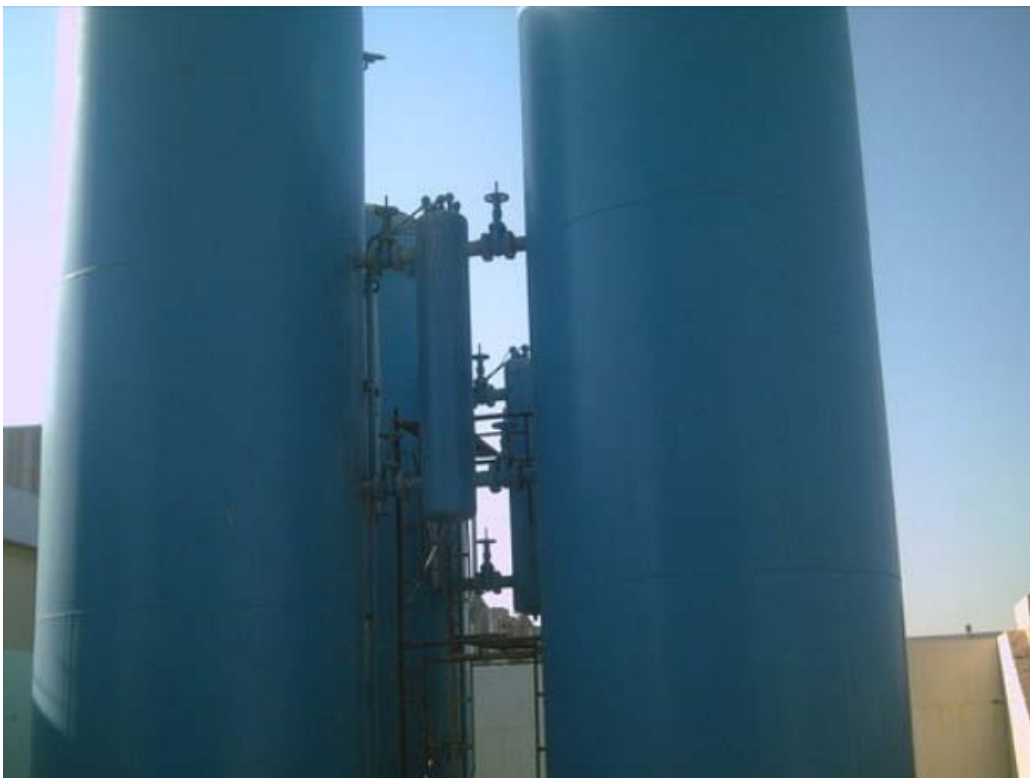
**Site Photo 11. Anti-hammer system (Photo courtesy of USACE)**

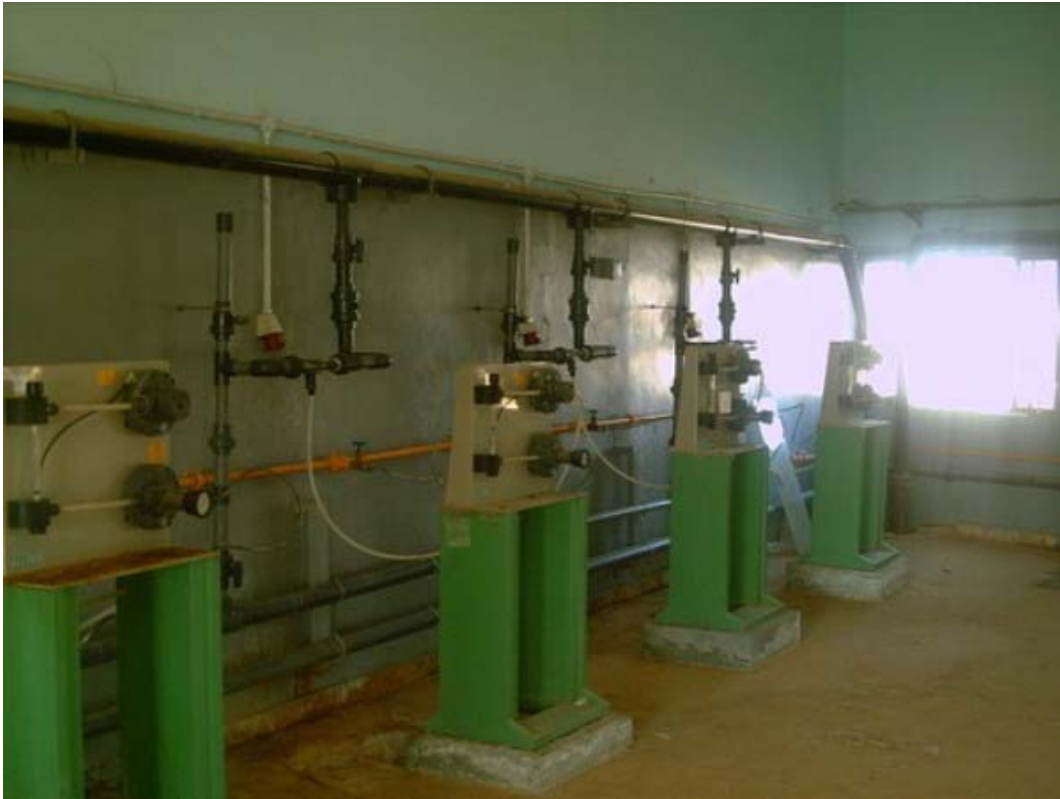
**Site Photo 12. Chlorine dosing sets (Photo courtesy of USACE)**

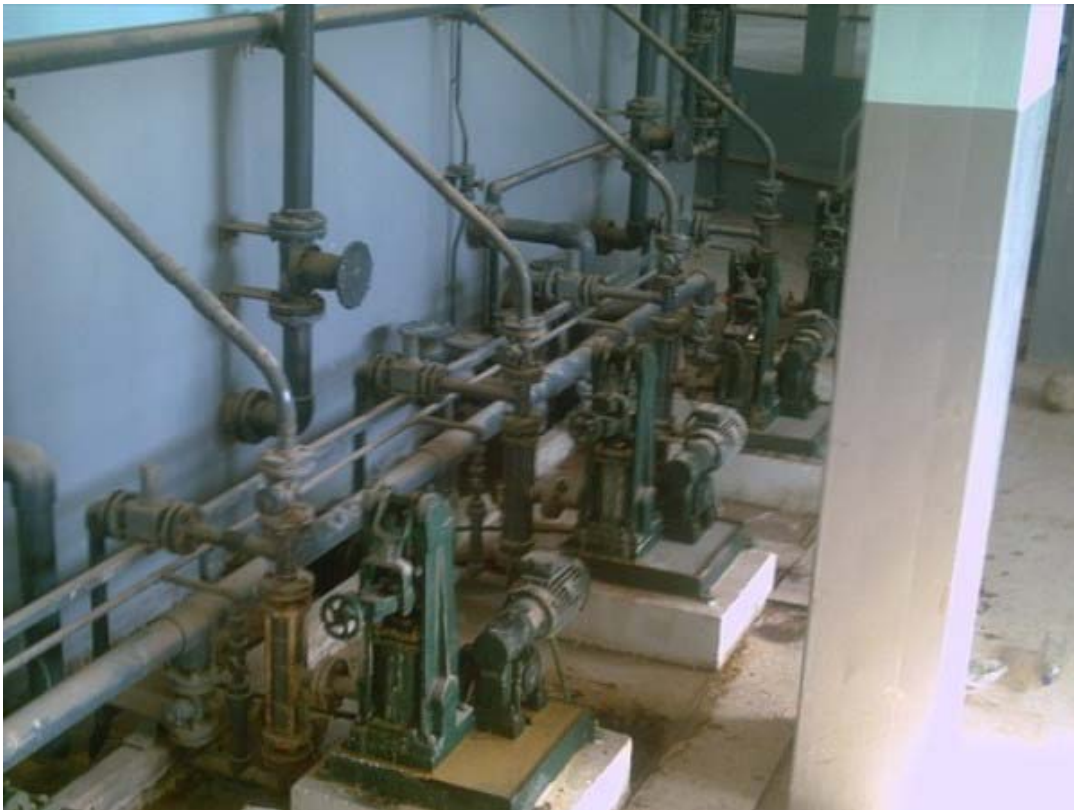
**Site Photo 13. Alum mixers (Photo courtesy of USACE)**

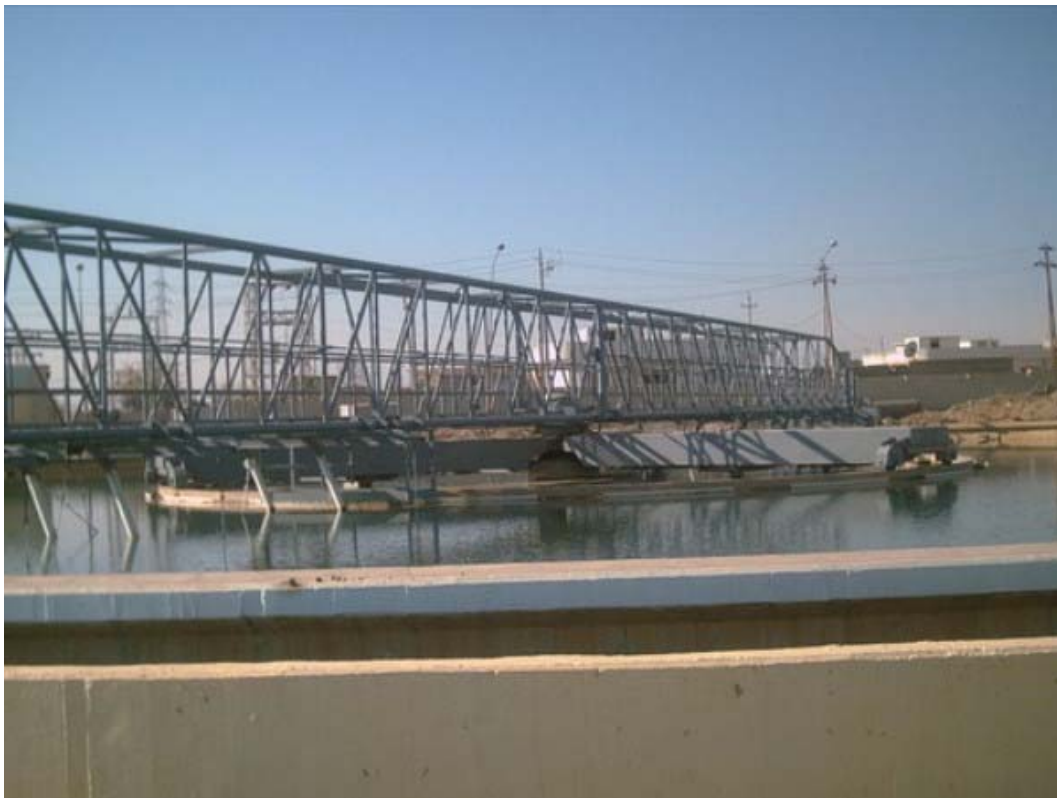
**Site Photo 14. Settling tank (Photo courtesy of USACE)**

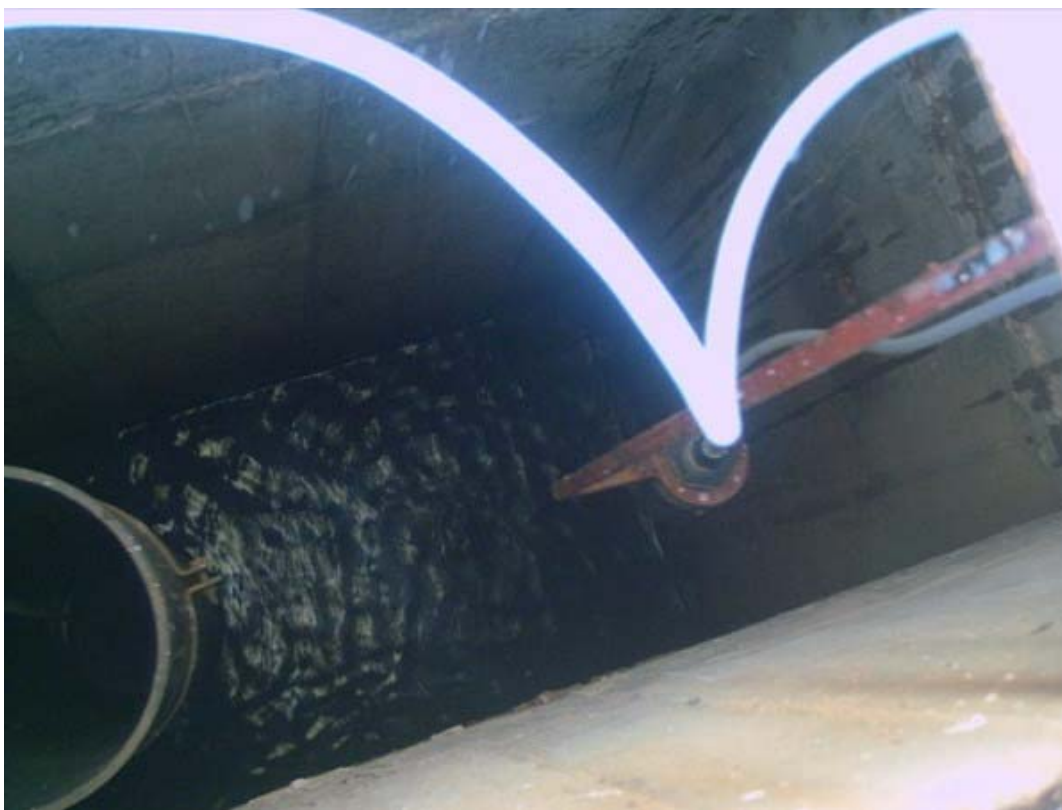
**Site Photo 15. Water level indicator (Photo courtesy of USACE)**
